#### Test Report No: BUR0357-FT-1 Report Date: July 23, 2024

**SAMPLE ID:** Bodaq General Type Vinyl Films, Super White Wood ZSW04 and Concrete NS401, applied to a 90-minute steel door.

This report documents the fire testing conducted by QAI Laboratories Ltd. for Nelcos Distribution Inc. on 2 Bodaq Vinyl Films in accordance with UL 10c, UL 10b and ULC S104. The Bodaq Vinyl Film was applied by the client to both faces of a listed 90-minute steel door to determine if the film would have any detrimental effects on the listed doors performance in accordance with the noted test procedures.

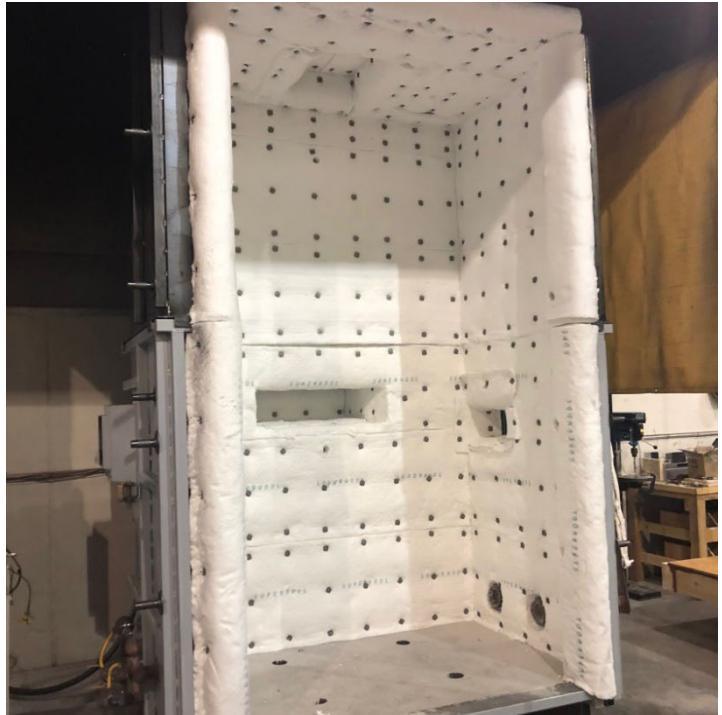
Figure 1: Test Furnace

The furnace used in the test is a mid-scale fire burning apparatus with interior dimensions of 10 ft. 4 in. (1.78 m) in height, 5 ft. 5 in. (1.65 m) in width, and 52 in. (1.32 m) in depth.

Temperatures within the furnace were monitored using eight thermocouples. The temperatures are controlled by adjusting fuel to the furnace burners to conform to the time/temperature curve specified by the test standards. Temperature measurements are recorded by a Agilent 34970A data acquisition unit (ID# ConeDAQ02) which passes the readings to a computer for graphical display and storage.

The door and frame assemblies were mounted in a vertical steel test frame. The test frame is then rolled up to the furnace and secured by chain and straps to the furnace opening.

Two pressure taps are installed along the longitudinal center line of the test assembly. The pressure taps are each attached and monitored by Setra model 264 pressure transducers (ID# Pressure T4 and Pressure T7). The furnace pressure is controlled by adjusting a damper in the furnace exhaust stack.

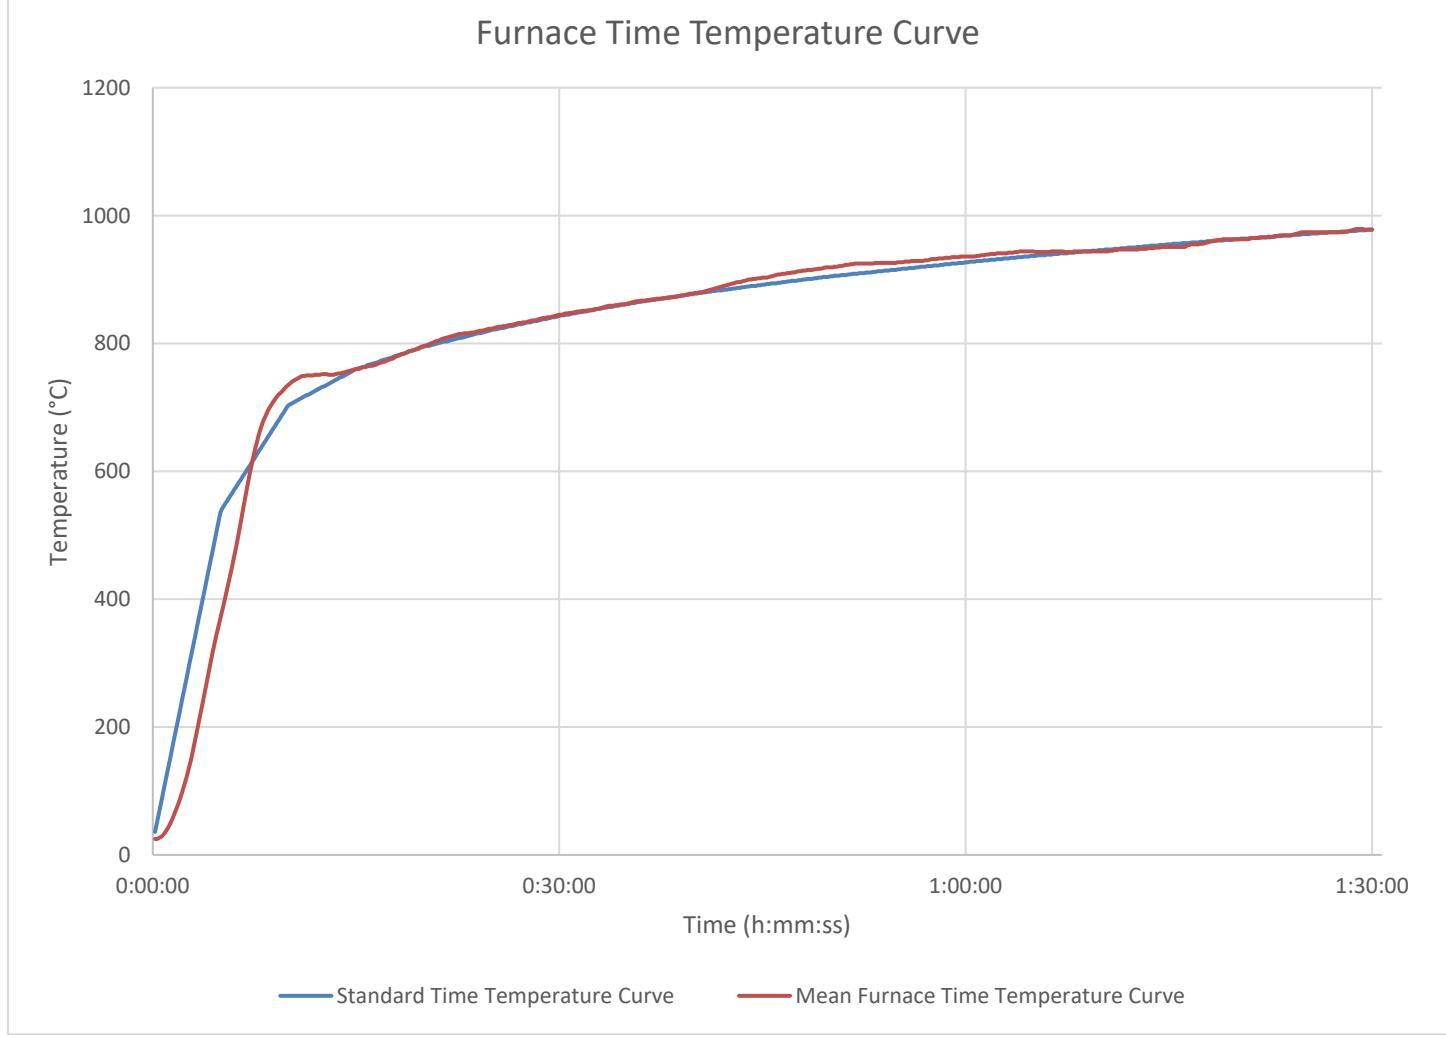
Figure 2: Furnace Time Temperature Curve.

Prior to the fire endurance test the test assembly was fastened to the front of the furnace, and the burners were ignited. The fire endurance test was initiated after igniting the burners. The temperature inside the furnace was controlled to follow the time/temperature curve within the limits described in the test standards.

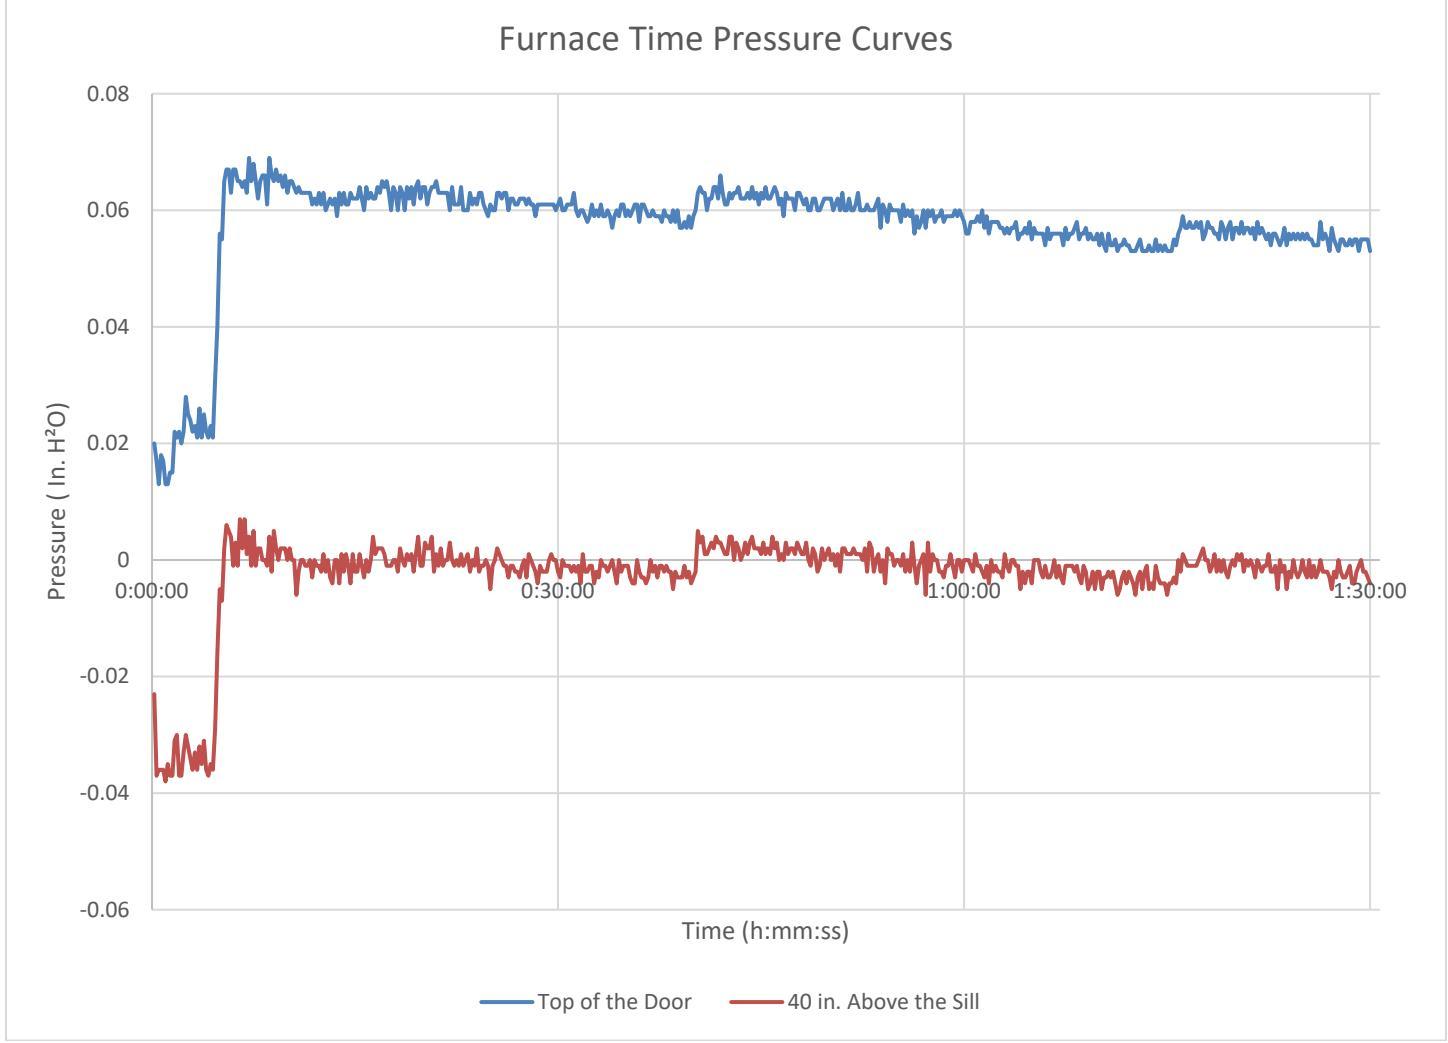
Figure 3: Furnace Time Pressure Curves.

The pressure was continuously monitored using calibrated pressure transducers. After the first 5 minutes of the test the pressure 40 in. from the sill was set to zero for the remainder of the test. This pressure condition is required by UL 10c and is considered a higher requirement than the pressure conditions required for UL 10b and CAN/ULC S104 hence by testing to UL 10c the product can show compliance to all 3 standards.

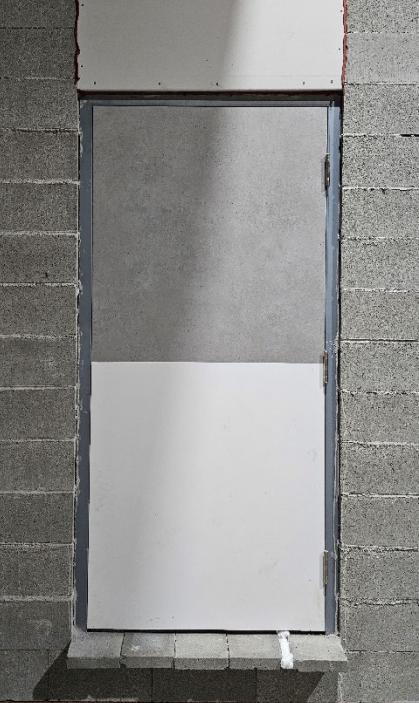
Figure 4: The exposed side prior to the fire test.

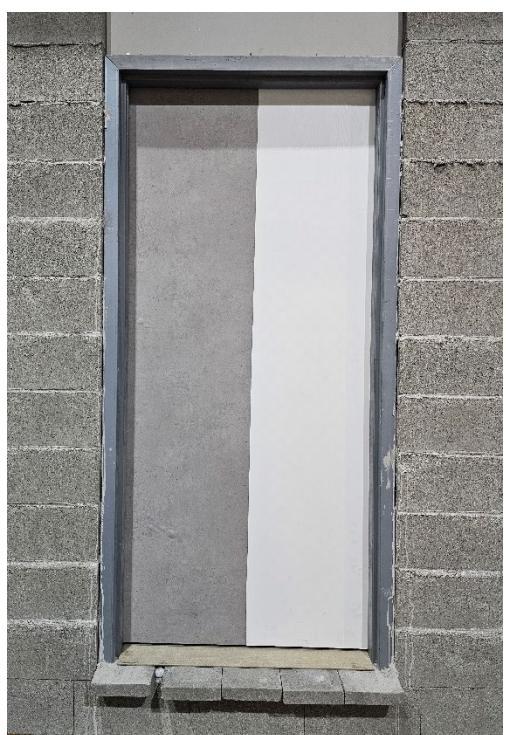
Figure 5: The unexposed side prior to the fire test.

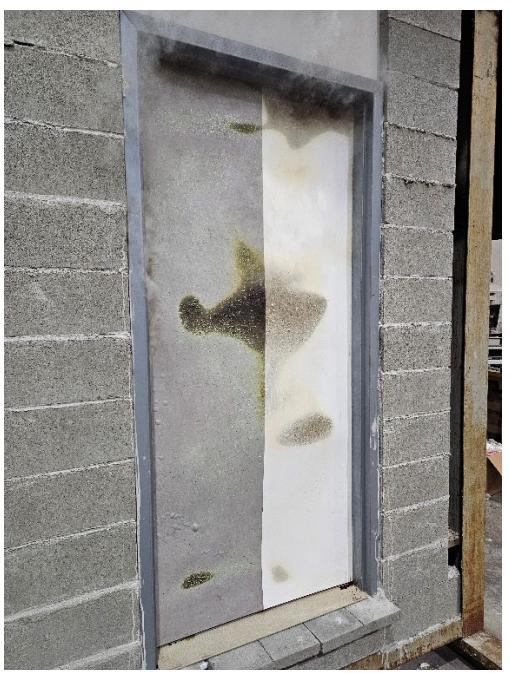
Figure 6: The unexposed side 7 min into test

Test Time (h:min:sec)	Unexposed	Exposed		
2:10		Top grey vinyl darkening		
2:35		All vinyl has ignited		
3:02		Vinyl extinguished		
3:40		Re-igniting traveling across surface		
4:10	Door warping			
4:25	Small bubbles forming on white vinyl	Flaming stopped		
6:11	Heavy venting from head and latch side of			
	door			
7:06	Darkening in middle of door			
7:55	Whole door face smoking			
8:40	Popping noises from door			
10:15	Door surface 90% burned off			
16:00	Left vinyl is all black, right vinyl small spot left			
	near bottom			
19:26	Flaking off door surface			
1:30:00	Test Discontinued

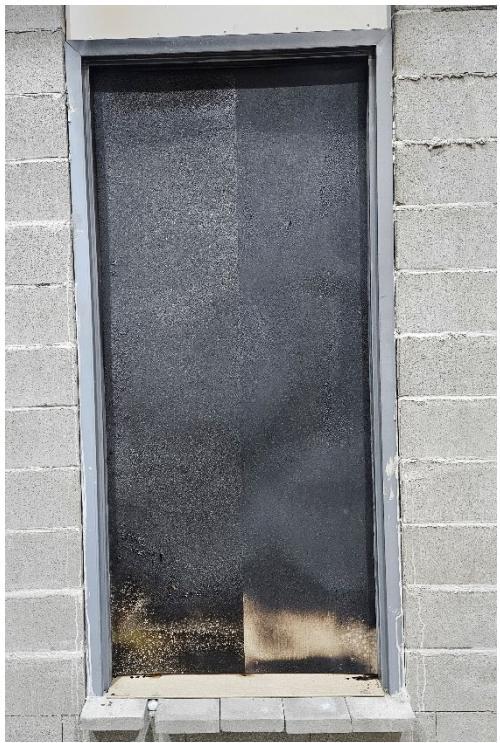
Figure 7: The unexposed side 16 min into test

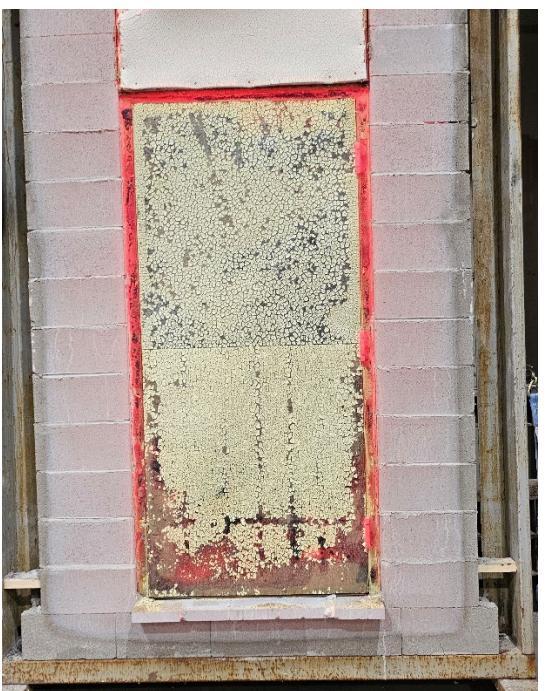
Figure 8: The exposed face at the end of the fire test.

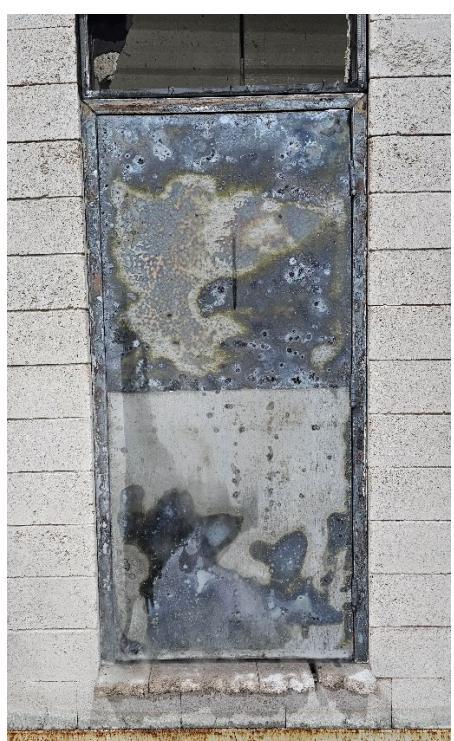
Figure 9: The exposed side after the hose stream test.

Immediately after the fire tests, a hose stream test was conducted for 34 seconds after the fire endurance test. The test assemblies successfully met the conditions of acceptance for the hose stream test: no through openings were developed that would allow a projection of water from the stream beyond the unexposed face during the time of the hose stream test.
